Big Bar Landslide

North of Big Bar on the Fraser River

July 19, 2019

SCALER UPDATES

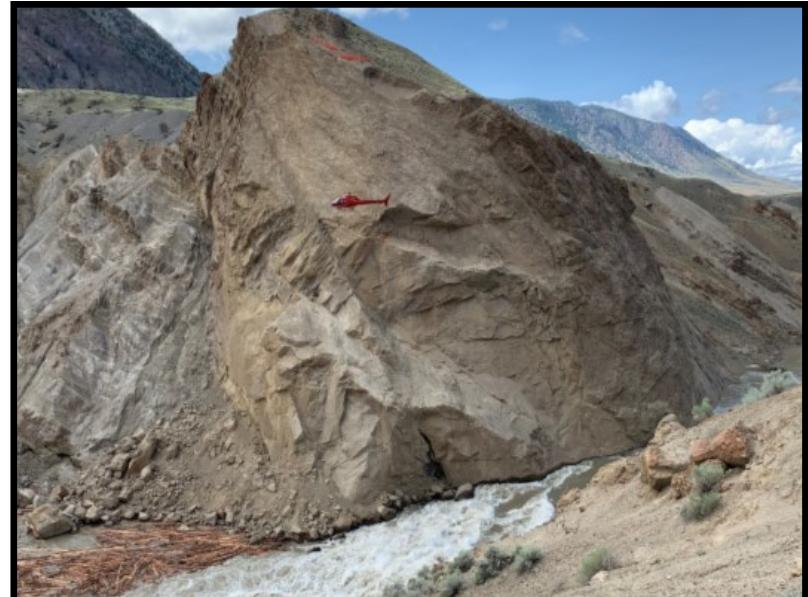
Figure 1. Scaler crews working on the cliff face as a helicopter passes.

Scaler crews continue to work on the face of the cliff, where the rock slide took place, removing dangerous rocks. This process ensures that the rocks will be safely removed in a controlled environment, to prevent another landslide from occurring and before personnel can work safely below.

Scaler crews are also beginning to prep a smaller remaining area on the face of the landslide for rock blasting. This preparation consists of carefully determining the placement of holes in the rock to maintain the stability of the larger rock face. The work will remove a specific area of rock located on the face that is dangerously overhanging the river. This section of rock can't be removed by scaler crews with hand tools. The main objective of detaching this rock from the face is to remove unstable and hazardous rocks in a time-efficient manner to ensure safe working conditions at the landslide site. The controlled detonations that will take place are non-toxic and are strategically placed to limit the size of rock that will detach, in order to prevent harming any fish that may be below.

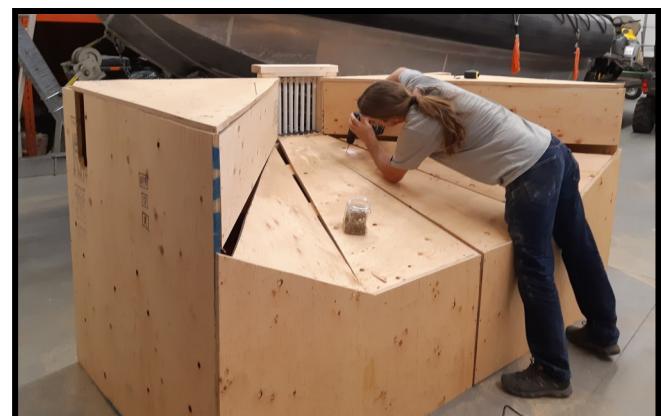
Figure 2. The fish weir being built for the holding pond.

- Pickets are being inserted into the river bottom that will direct fish through a newly-built fish weir and into an off-channel holding pond, downstream of the landslide area. A fish weir is a structure, as shown in figure two, that allows fish to swim into but not out of, essentially acting as a fish trap. This setup will allow fish to enter the calm waters of the pond where the fish will then be collected and moved beyond the partial blockage upstream. The purpose of this operation is to displace the fish further upstream in a safe spot, away from the landslide, where they will be able to continue their migration and spawning journey.
